# Operation UPSHOT-KNOTHOLE

Project 3.29

BLAST EFFECTS OF ATOMIC WEAPONS  
UPON CURTAIN WALLS AND PARTITIONS  
OF MASONRY AND OTHER MATERIALS

Issuance Date: April 21, 1959

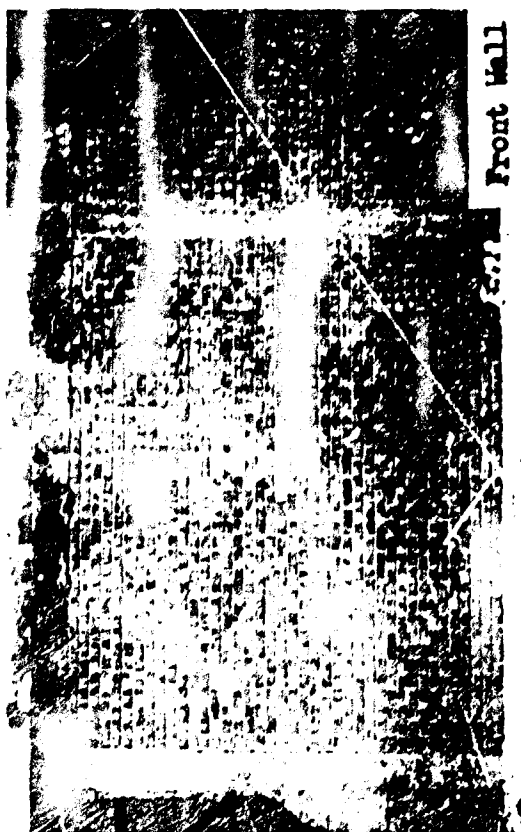
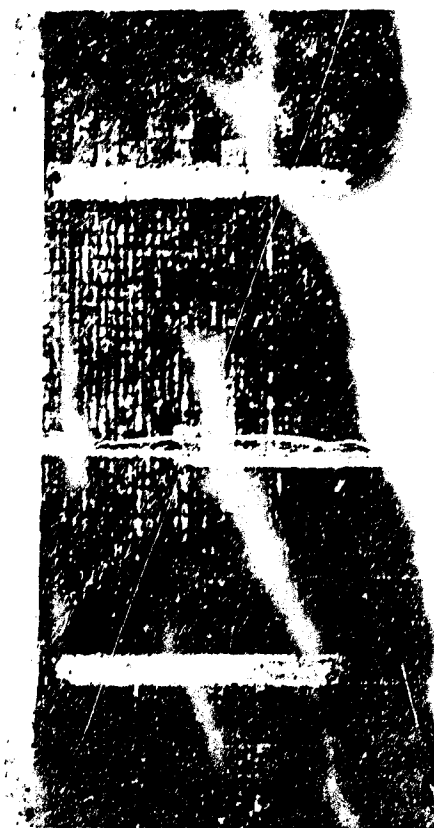
Fig. 2.14 Post Shot Photography - Cell No. 3a

The front wall was slightly spalled, at the top, on the outside face.

The rear wall was slightly spalled, at the top, on the outside face.

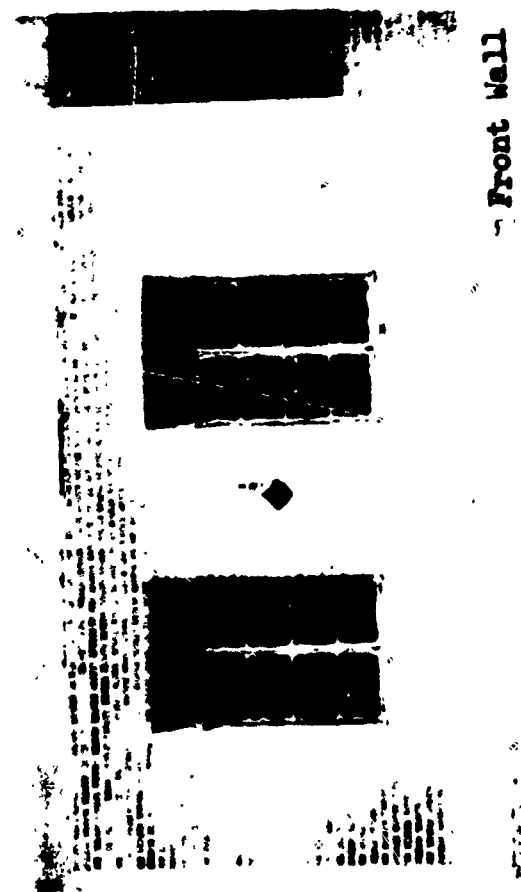
Fig. 2.48 Post Shot Photography - Cell No. 1b

The front wall was spalled at the top on the outside face. The window frames were bowed in slightly at the cross rail.

The rear wall was marked on the inside face and spalled on the outside face at the top, north edge.

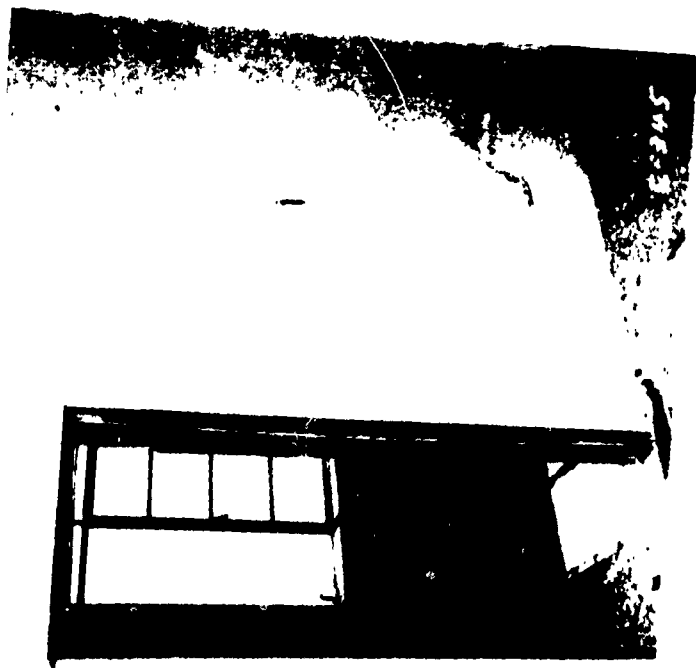
Fig. 2.49 Post Shot - Interior - Cell No. 1b

The front partition had its door torn out and was badly cracked. It was slightly bowed.

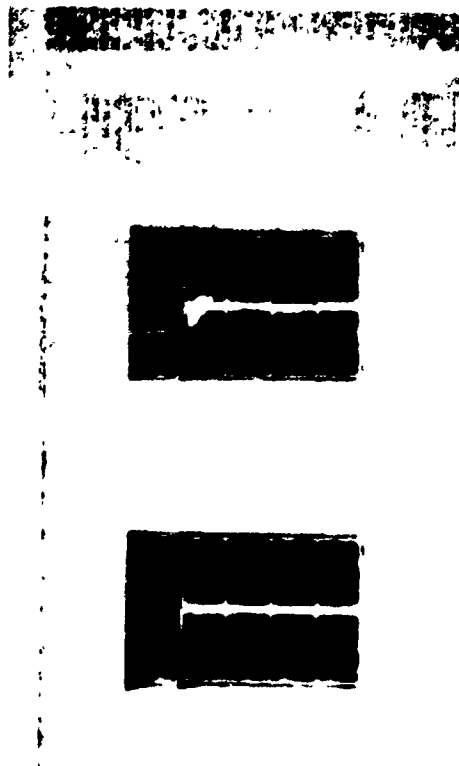
Fig. 2.67 Post Shot Photography - Cell No. 6b

The front wall was spalled at the top on the outside face.

The rear wall was slightly spalled at the top on the outside face. The inside face was covered by the partitions.

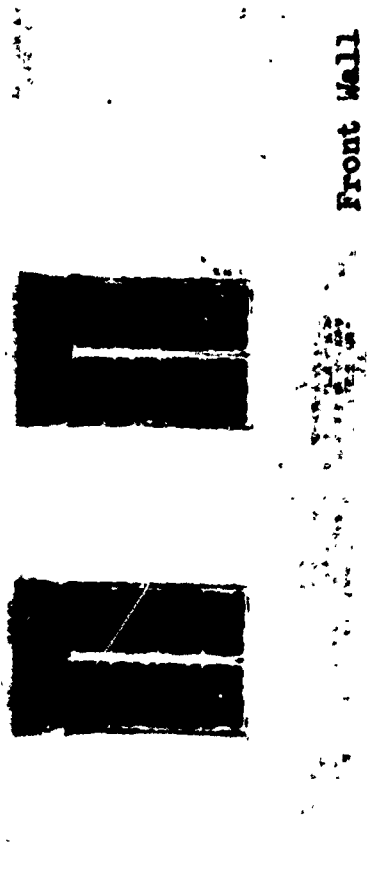
Fig. 2.70 Post Shot Photography - Cell No. 7b

The front wall was slightly spalled at the top on the outside face. The window frames were bowed in.

The rear wall was slightly spalled at the top on the outside face.

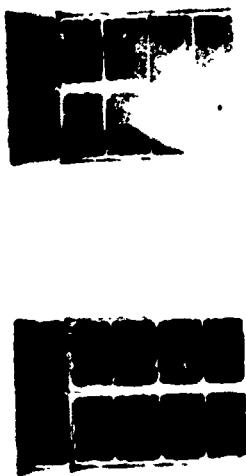
Fig. 2.81 Post Shot Photography - Cell No. 11b

The front wall was cracked on the inside face at a mortar joint 4 cinder blocks up from the bottom in the center section. The outside face was cracked opposite the crack on the inside face. The window frames were bowed in.

The rear wall, south section, had a few medium punched holes into the cinder block cells on the inside face with a vertical hair crack at the top right. The outside face was slightly spalled at the top.

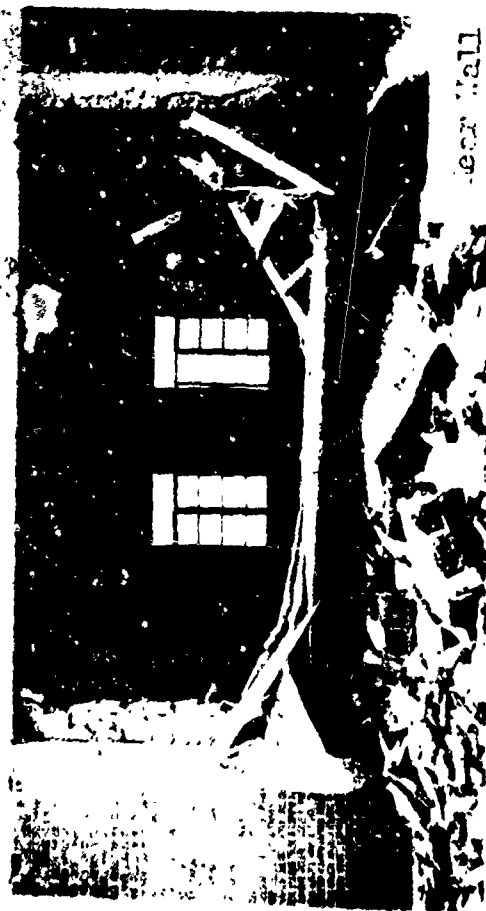
Fig. 2.178 Post Shot Photography - Cell No. 5d

The front wall was cracked at the sill line on the outside face. The window frames were bowed in with the upper muntins blown out. The inside face was cracked horizontally 2 block courses high.

The rear wall was blown out except for 1 ft at the side edges.

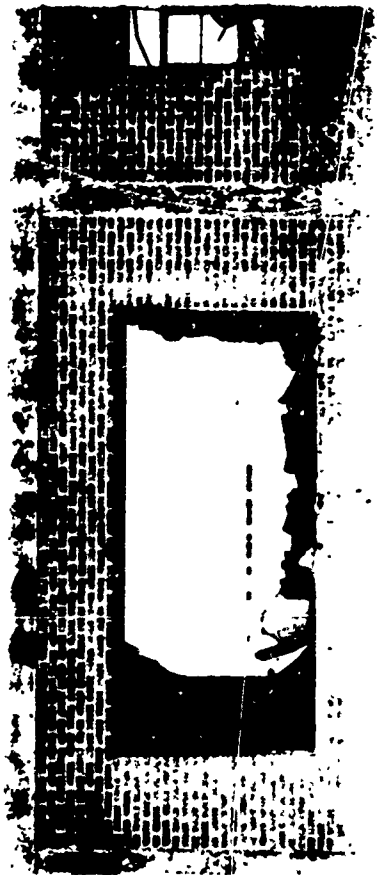
The front wall was bowed in 1/4 in. at the top and bottom with a vertical crack in the center, above and below the window. The window was broken into 3 sections and blown into the cell with the inner angle of the lintel blown down.

The rear wall was blown out except for 1 ft at the edges.

Fig. 2.214 Post Shot Photography - Cell No. 15d

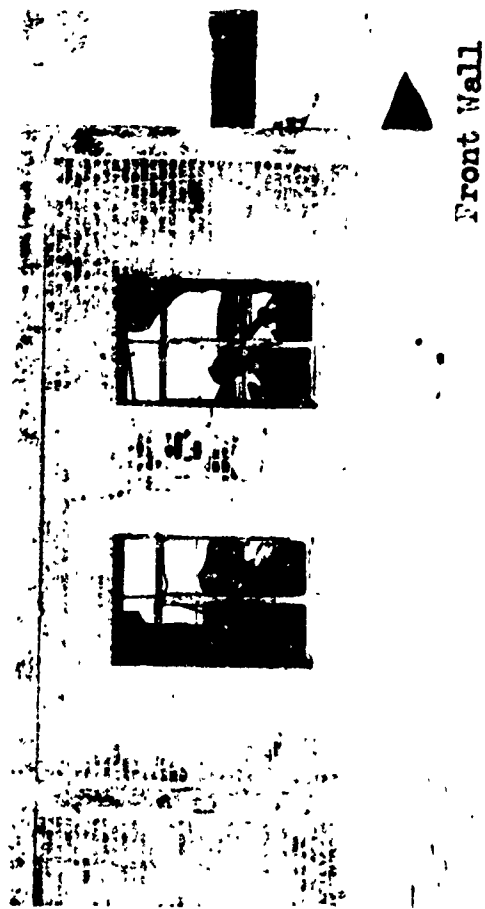
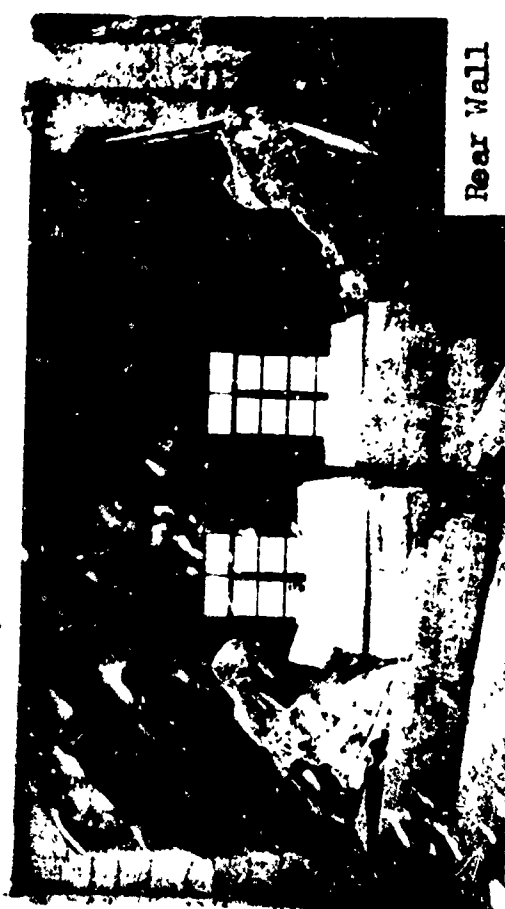
The partitions were torn loose and blown thru the cell.

The front wall was bowed in 1/2 in. at the top center. The window frames were bowed in. The outside face was cracked at the 5th mortar joint above the sill line, in the center section. The inside face was bowed into the cell 1/2 in. at the 2nd mortar course above the sill line, with the cinder block separated from the brick.

The rear wall was blown out except for 1 ft at the edges.

Fig. 2.218 Post Shot Photography - Cell No. 16d

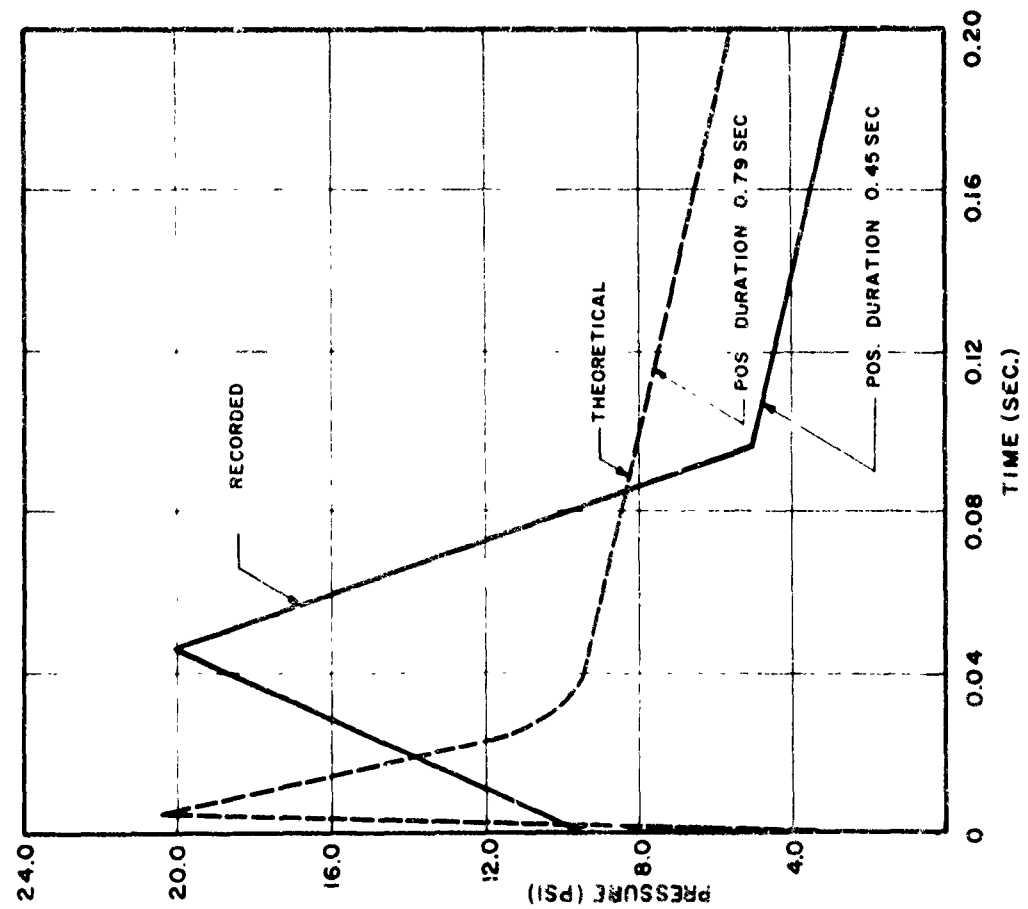
Fig. 3.1 Comparison of Recorded and Theoretical Front Wall Pressures - Bldg. 3.29c

The recorded blast pressures on the front and rear walls of Structures 3.29a (6,650 feet from ground zero) and 3.29c (4,450 feet from ground zero) are shown in Figures 2.3 and 2.4. It was necessary to approximate the poorly defined front wall pressure records by pressure curves with a line variation as shown in Figures 3.1 and 3.2. For comparison, computed theoretical pressures are shown on the same figures. Because of the apparent discrepancies between the recorded and theoretical values of the front wall pressures, many of the test panels have been analyzed for both theoretical and recorded pressures. No explanation is available at present to account for these discrepancies. Close agreement between recorded and theoretical values of front wall pressures was noted on a series of structures located approximately 5,000 feet from ground zero.

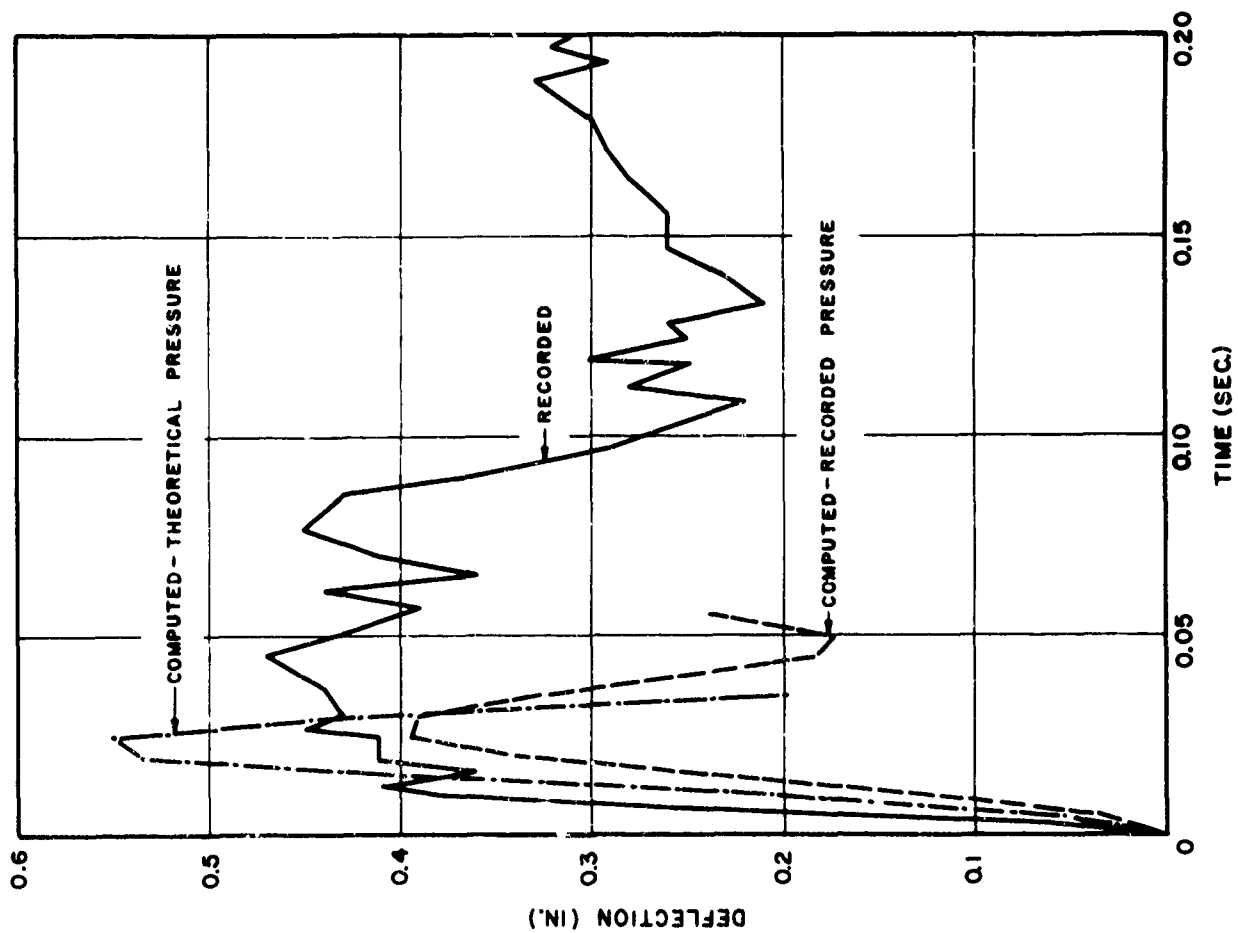
Fig. 3.5 Comparison of Recorded and Computed Deflections - Bldg. 3.4a - Panel 1F

Panel 1F. The comparison between computed and recorded response for Panel 1F (Figures 3.5 and 3.6), a 12-inch brick wall at both ranges, was extremely good. At the far range good agreement was obtained using both recorded and theoretical pressures, while at the near range the recorded pressures indicated failure and the theoretical pressures indicated no failure. As a check on the assumed masonry mortar unit strength of

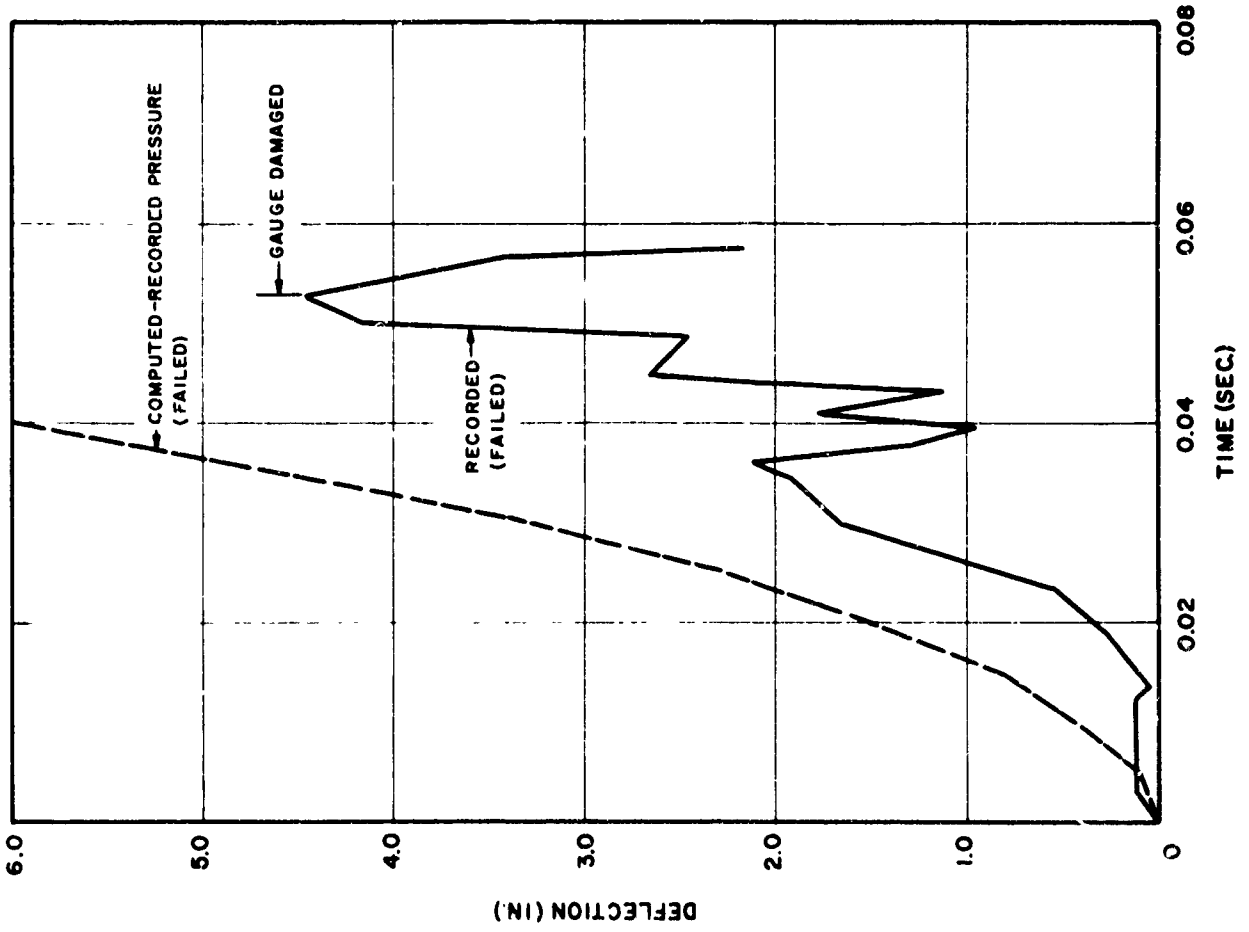
Fig. 3.7 Comparison of Recorded and Computed Deflections Bldg. 3.29a - Panel 10F

Panel 10 F. The computed response (using recorded pressures) for Panel 10F, a 4-inch-brick and 8-inch-block wall, at the far range (Figure 3.7) indicated that failure, which did not occur, would occur. A study was made to show the effect of possible variations in the strength (or the modulus of elasticity) of the masonry unit. The results of this study, as shown in Figure 3.8, demonstrate the sensitivity of the response function to small changes in strength. As shown, the computed response would compare extremely well with the recorded data if the assumed strength of the unit (1,000 psi) were to be increased by approximately 10 percent. The comparison between computed and recorded response for the corresponding panel at the near range (Figure 3.9) was satisfactory to the extent that failure was indicated by the analysis. The recorded response showed an initial time lag considerably larger than the response time of the recording instrument, otherwise the calculated response is shown to build up at a rate comparable to that of the recorded values.

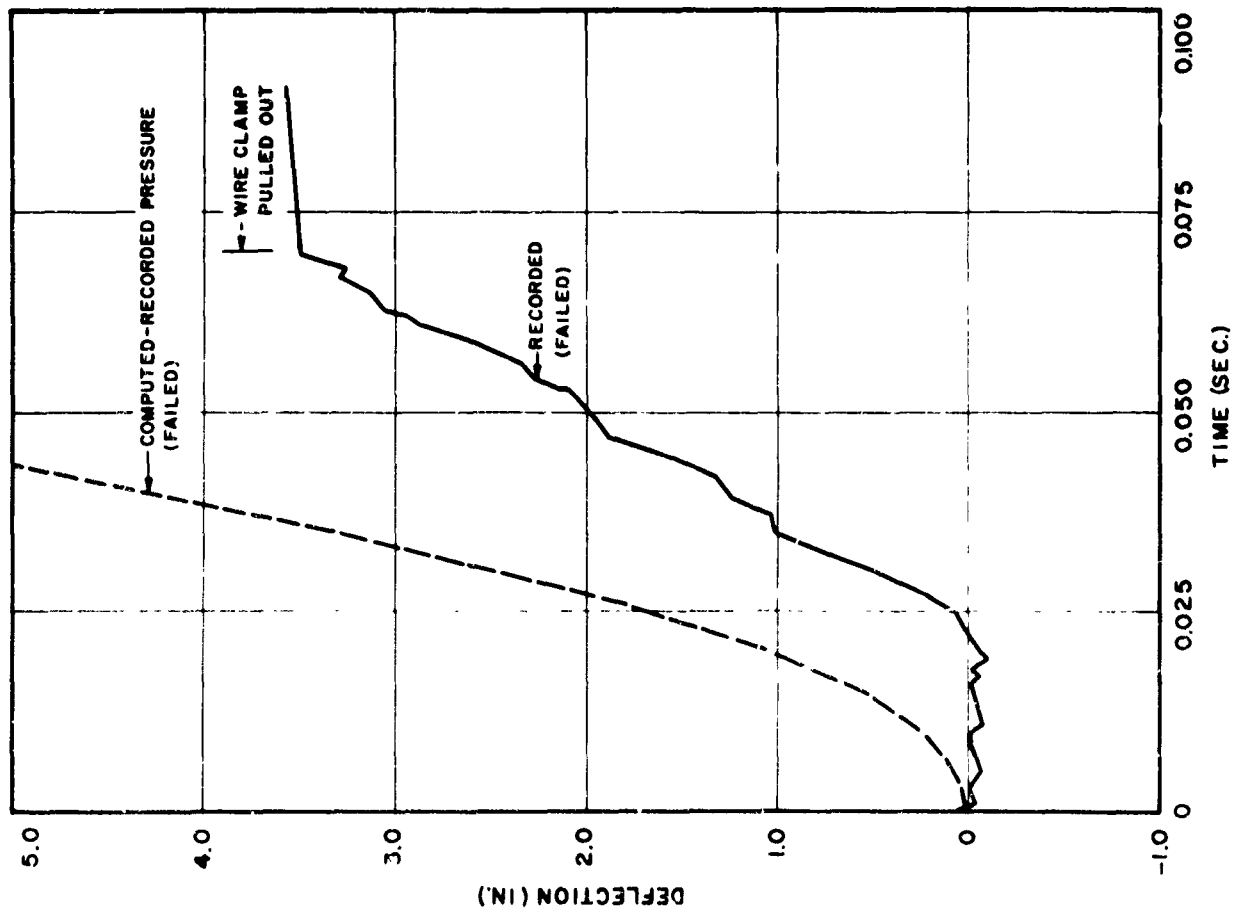
Fig. 3.10 Comparison of Recorded and Computed Deflections - Bldg. 3.29a - Panel 11F

Panel 11 F. The comparison between computed and recorded response for Panel 11F, a 4-inch-brick and 4-inch-block wall (Figure 3.10) at the far range, was satisfactory to the extent that failure was indicated by the analysis. Except for an initial time lag demonstrated by the recorded response, the rates of build-up of recorded and computed response compare extremely well. The corresponding panel at the near range also failed.

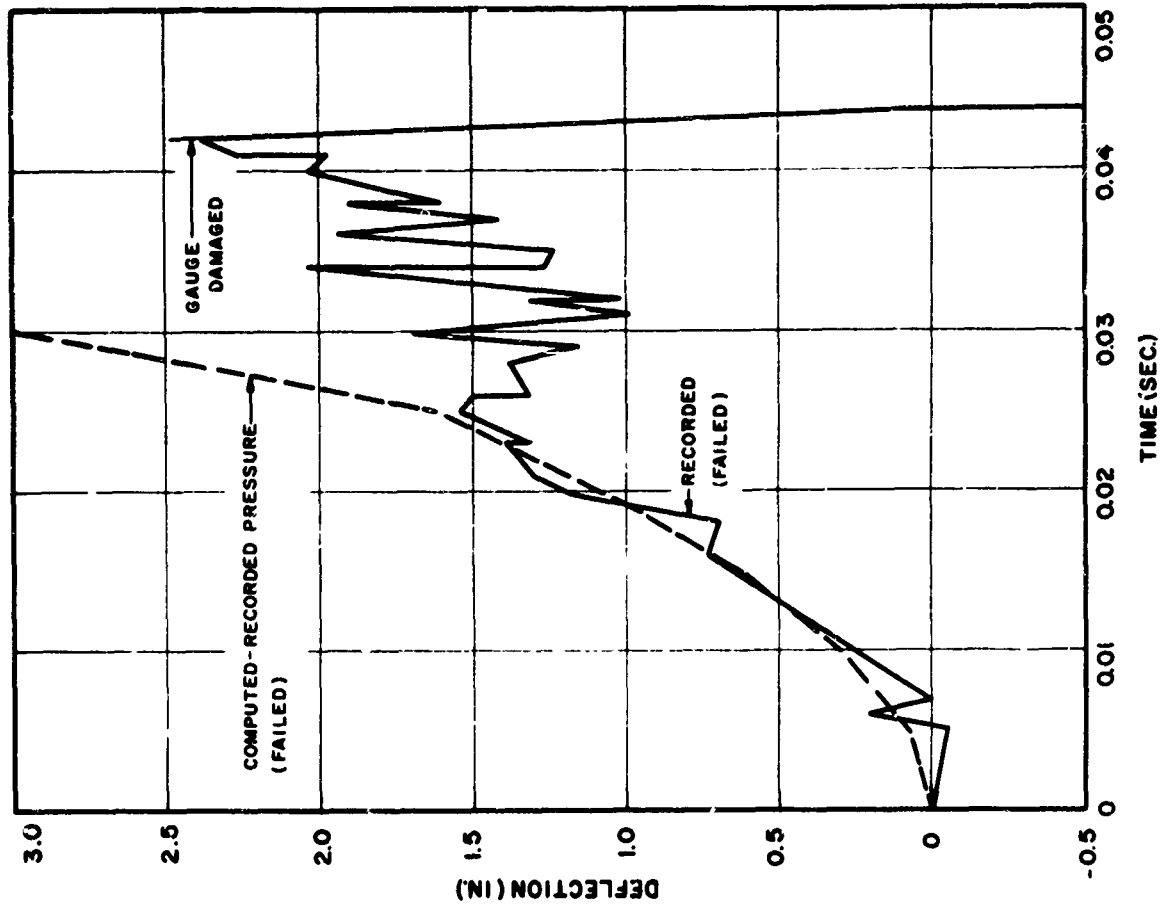
Fig. 3.11 Comparison of Recorded and Computed Deflections - Bldg. 3.29a - Panel 12F

Panel 12 F. The comparison between computed and recorded response for Panel 12F, a 4-inch-brick and 8-inch-block wall with a clearance of 0.75 inch between the top of the panel and the bottom of the roof slab (Figure 3.11) at the far range, was satisfactory to the extent that failure was indicated by the analysis. Except for an initial time lag demonstrated by the recorded response, the rates of build-up of recorded and computed response compare extremely well. The corresponding panel at the near range also failed.

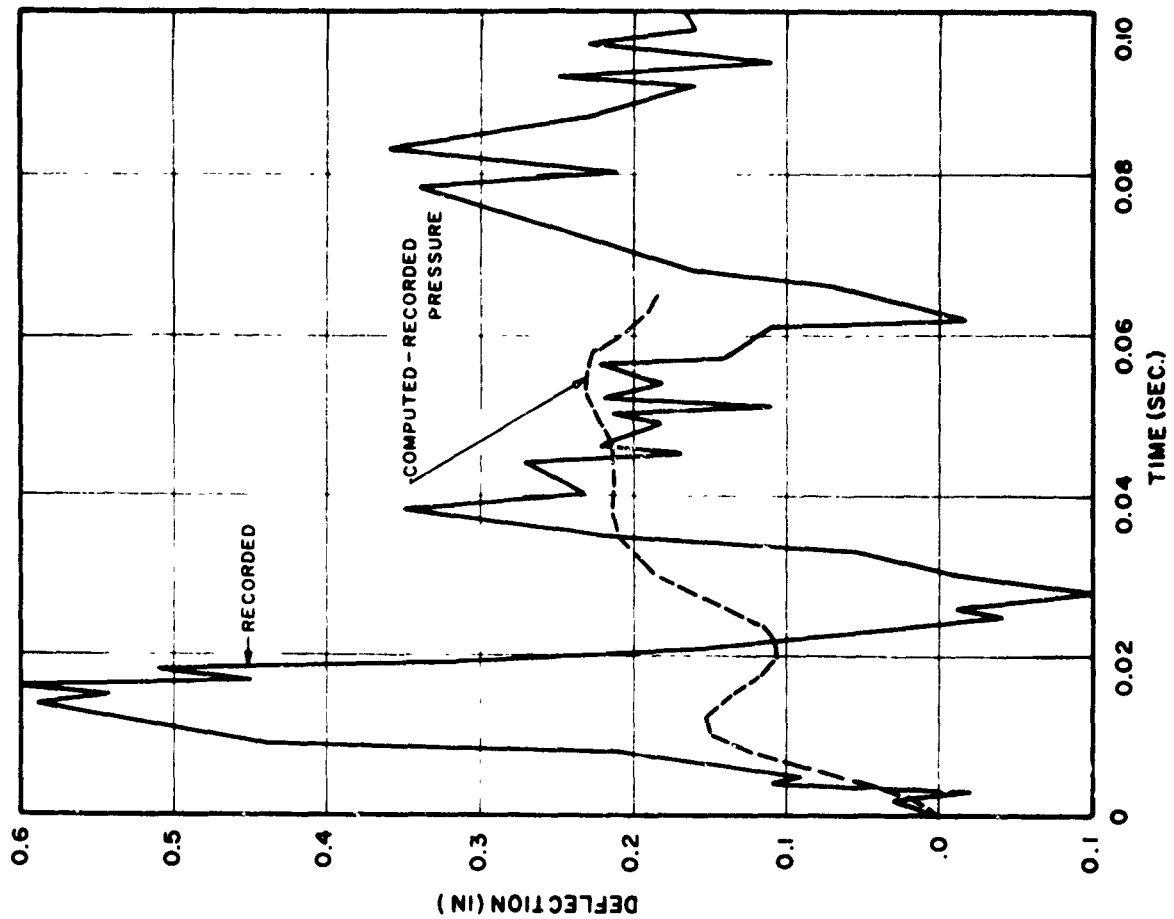
Fig. 3.12 Comparison of Recorded and Computed Deflections - Bldg. 3.29a - Panel 13F

Panel 13 F. The comparison between computed and recorded response for Panel 13F, a 4-inch-brick and 4-inch-tile wall (Figure 3.12) at the far range, was satisfactory to the extent that failure was indicated by the analysis. Very good agreement was obtained between the recorded and computed rates of build-up of the response function. The corresponding panel at the near range also failed.

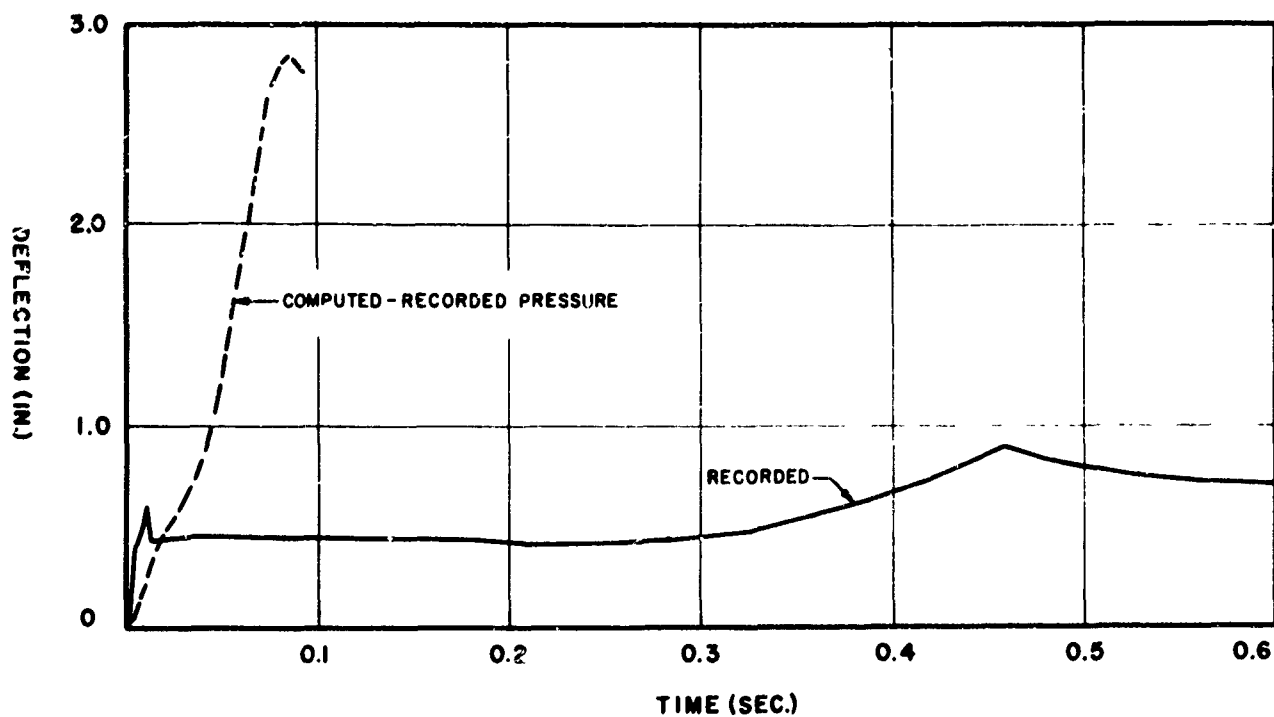
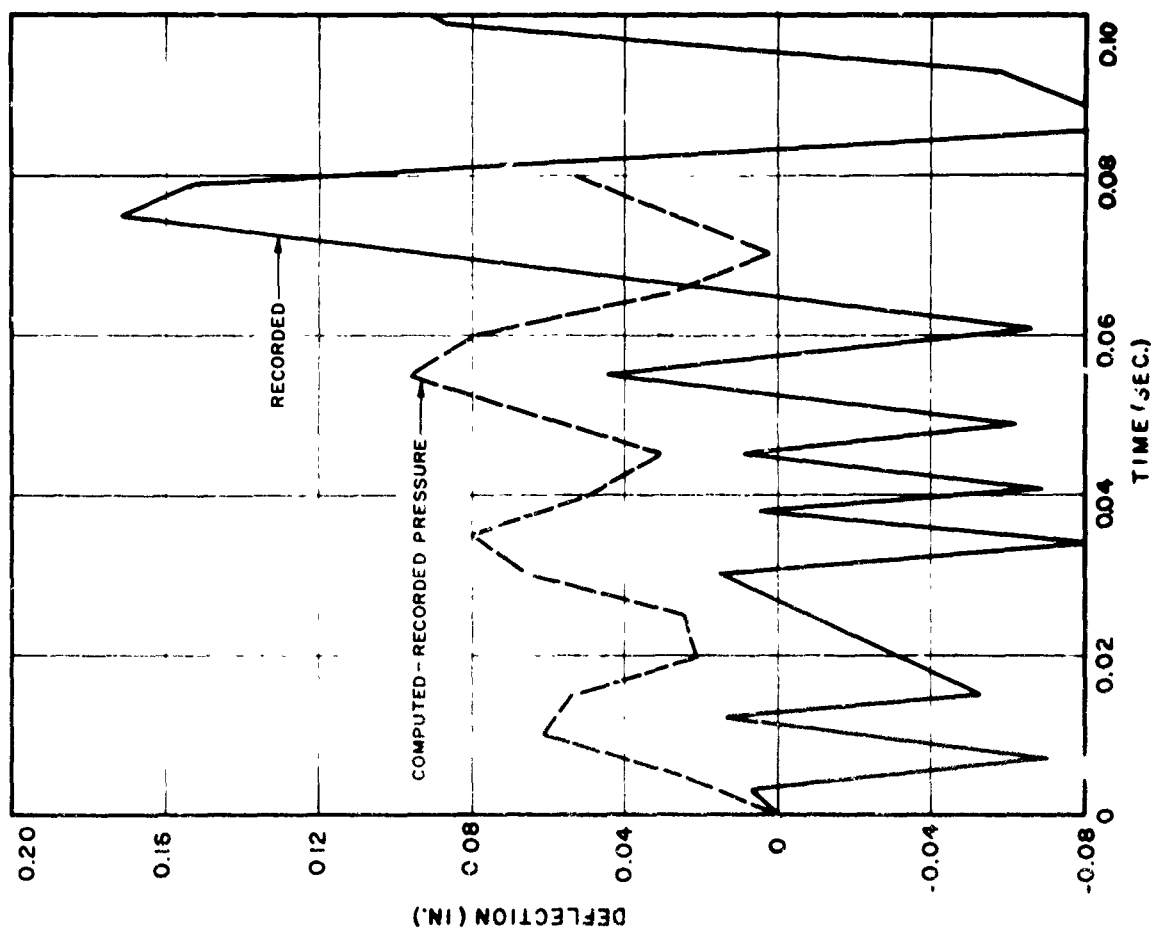
Fig. 3.13 Comparison of Recorded and Computed Deflections - Bldg. 3.29a - Panel 14F

Panel 14 F. The computed response values for Panel 14F, an 8-inch reinforced-concrete panel, restrained top and bottom (Figures 3.13 and 3.14) at both ranges, were lower than the recorded values. Closer agreement would be possible if the steel reinforcement, for which field test data is not available, were to exhibit a lower yield point than assumed for analysis, or if the panel reinforcing were not properly tied in at the roof or floor slab. Both panels showed better agreement when analyzed with the theoretical pressures.

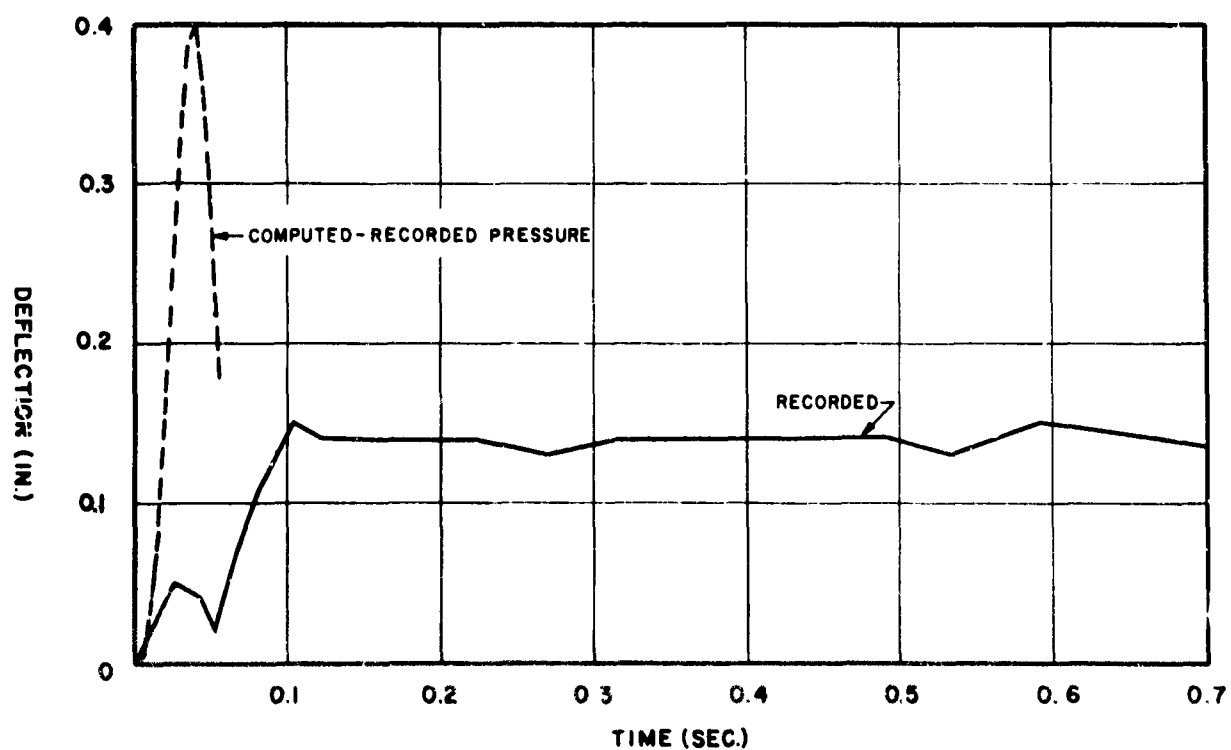
Fig. 3.15 Comparison of Recorded and Computed Deflections - Bldg. 3.29c - Panel 15F

Panel 15 F. The resistance function for Panel 15F, a 12-inch reinforced-brick panel at the near range (Figure 3.15), is not as intended because of the field omission of negative-moment steel at the roof level. The panel deflected inward 1 foot along the top edge, and some extent of horizontal spanning was indicated by the presence of vertical cracks at the middle top third of the panel. Depending upon the tightness of the mortar joint at the roof level, the amount of cracking in the panel, and the magnitude of the vertical load, it is possible that the initial behavior of the panel was between that of a cantilever and a fixed-pinned member. The panel evidently did not develop a sufficient horizontal reaction at the roof level, and the effect of horizontal spanning may have prevented

failure. As a fixed-pinned member, the computed value of maximum deflection was 2.85 inches. This deflection is greater than the peak recorded value (0.89 inch). Considering the 1-foot displacement of the panel at the roof level, however, it appears that the recorded displacement should have been larger; this conclusion is indicated further by the postshot photography.

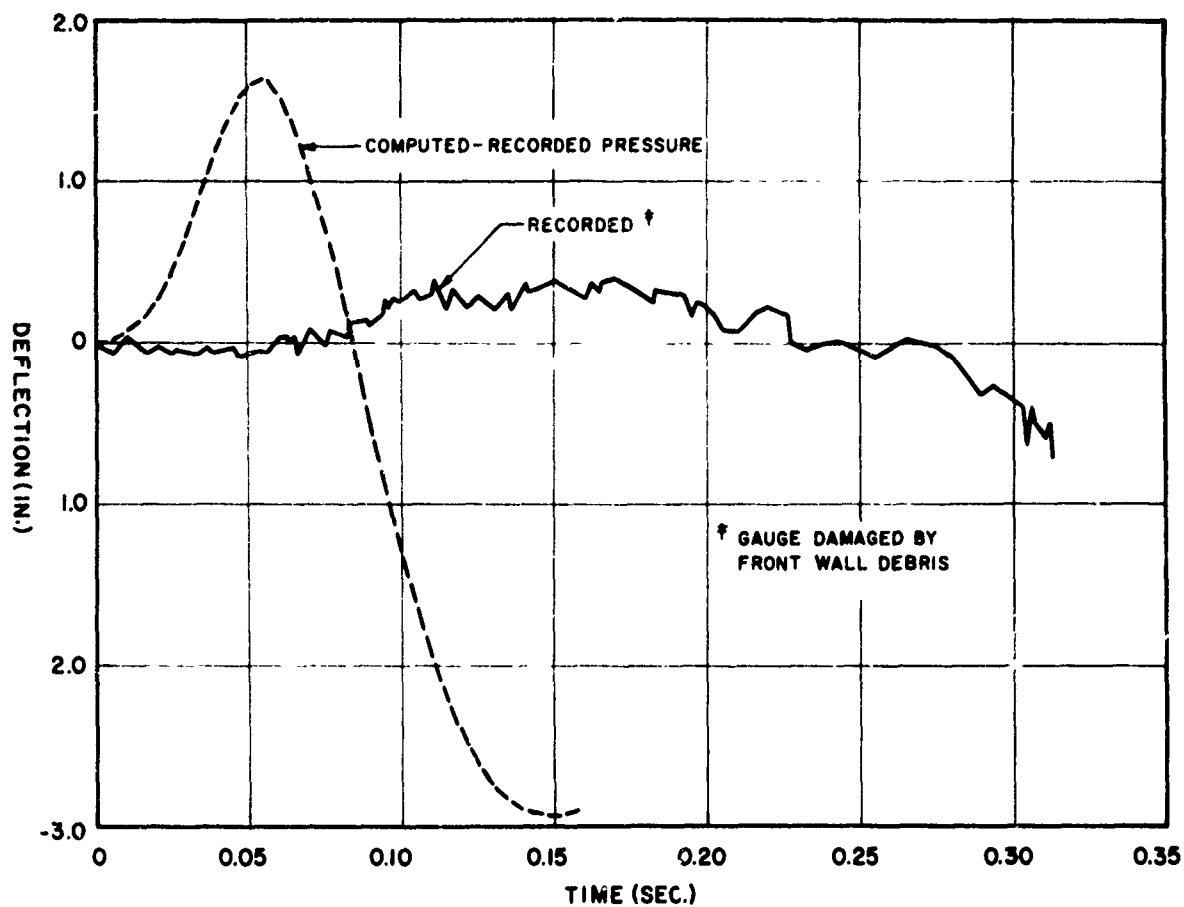
Fig. 3.16 Comparison of Recorded and Computed Deflections - Bldg. 3.29a - Panel 10H

Panel 10R. The maximum value of the computed response for Panel 10R, a 4-inch-brick and 8-inch-block wall at the far range (Figure 3.16), was considerably larger than the recorded value. As previously noted, a small increase in the material strength would result in much closer comparison.

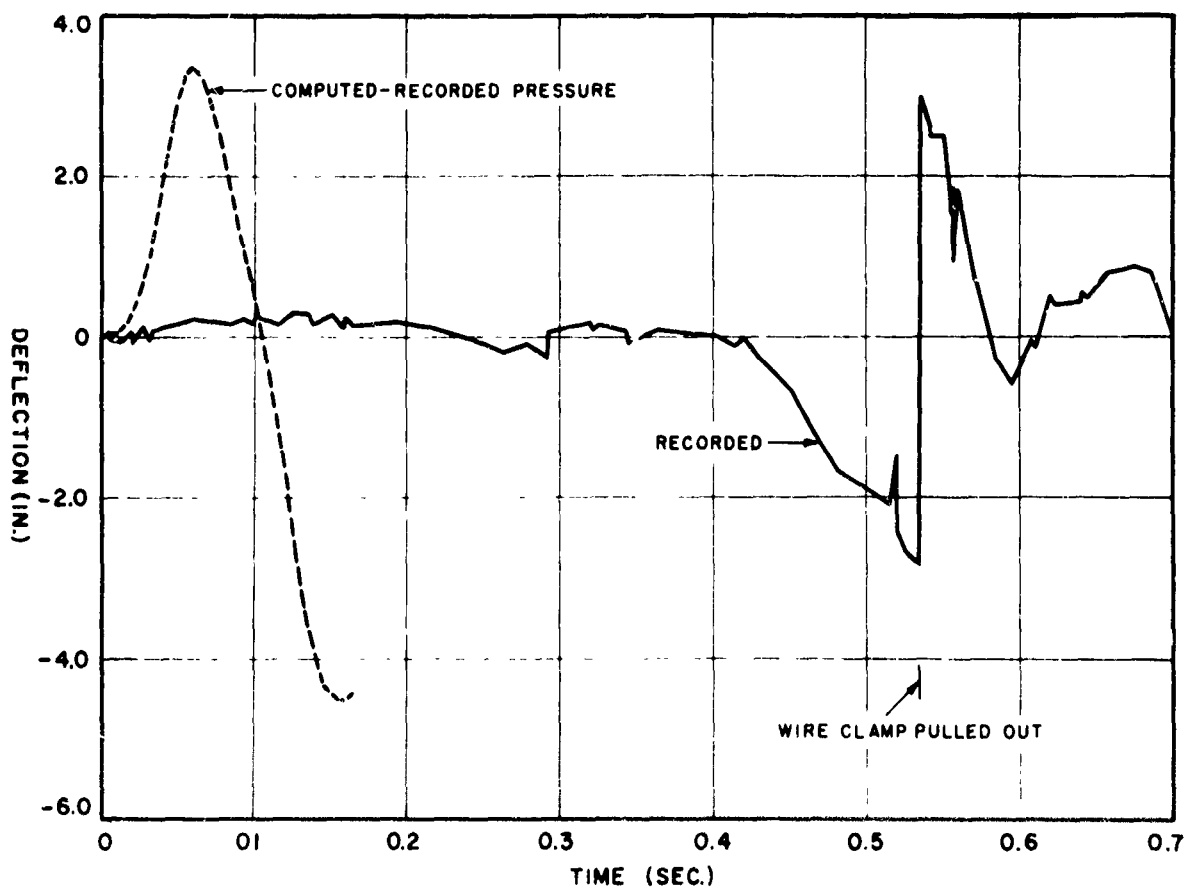
Fig. 3.17 Comparison of Recorded and Computed Deflections - Bldg. 3.29a - Panel 11R

Panel 11R. Panel 11R is a 4-inch-brick and 4-inch-block wall which survived at the far range. The corresponding front wall panel, 11F, failed at this range. The comparison between computed and recorded values of deflection is shown in Figure 3.17. The computed values are greater than the recorded values, but much better agreement could not be hoped for where so many variables are involved. The recorded values are questionable because of damage to the gage cable caused by debris. Further study is required with regard to the interior pressure.

The corresponding panel at the near range failed as indicated by analysis.

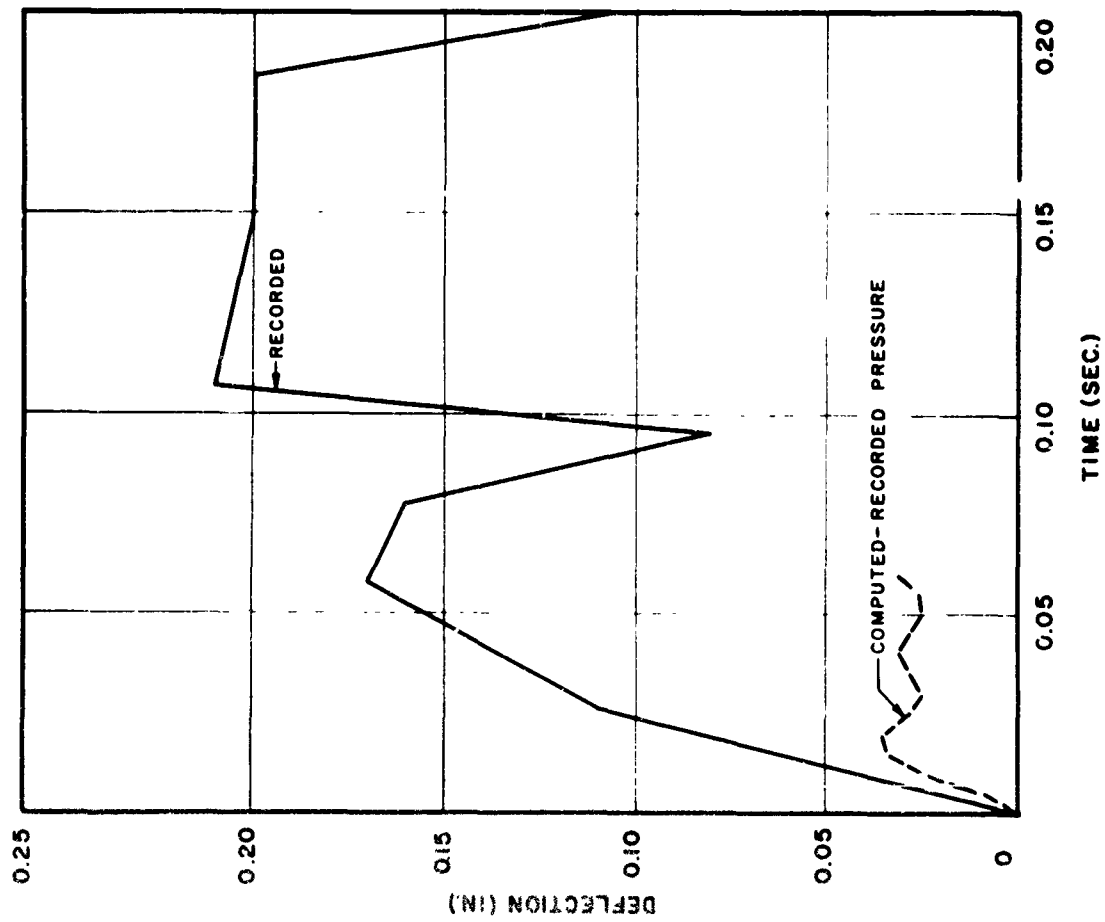
Fig. 3.18 Comparison of Recorded and Computed Deflections- Bldg. 3.29a - Panel 12R

Panel 12R. The loading on Panel 12R, a 4-inch-brick and 8-inch-block wall with a clearance of 0.75 inch between the top of the panel and the bottom of the roof slab which survived at the far range, is similar to the loading on Panel 11R in that the corresponding front wall panel failed. The comparison between computed response and values is shown in Figure 3.18. The computed values are greater than recorded. However, the record may be in error due to failure of the wire clamp.

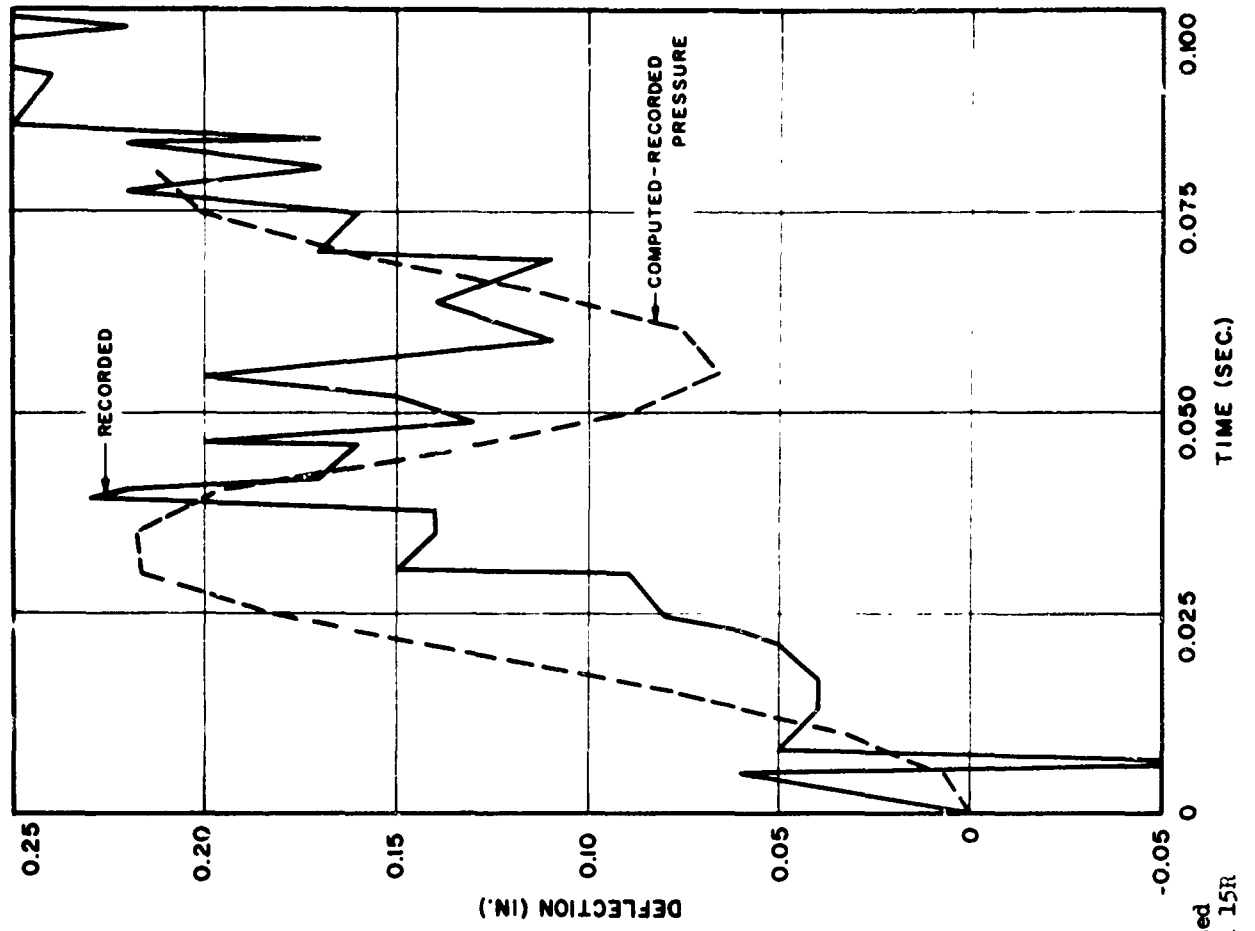
Fig. 3.19 Comparison of Recorded and Computed Deflections - Bldg. 3.29c - Panel 14R

Panel 14R. Poor agreement was obtained between computed and recorded response values for Panel 14R, an 8-inch reinforced-concrete wall at the near range (Figure 3.19). Both the computed and recorded values indicated virtually no plastic action of the panel, therefore a lower than assumed materials strength would not result in much closer agreement. It has been found that the type of deflection gage which was used is not satisfactory for measuring small displacement, having a lower limit of about 0.50 inch and an accuracy of  $\pm 0.0625$  inch. Since the peak recorded deflection was only 0.21 inch it is possible that the actual values were greater.
